Effects of bushfire on stream ecology

By Tom Nelson and Ann Milligan

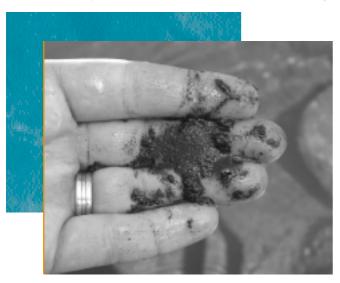
Black sediment was common in the Cotter River after the severe fires the month before. Photo: F Dyer

the streambed of the Cotter River in places where there was an irregular rock and gravel bed before. Soil has been destabilised on the hillslopes by intense heat and the loss of plant roots during the fires, and thunderstorms since have washed it into the river. Other sediment has banked up nearby, poised to wash in if there is more heavy rain. Sediment clogs up the crevices and niches in the gravel and cobbles of a natural riverbed, destroying this habitat for a range of small creatures.

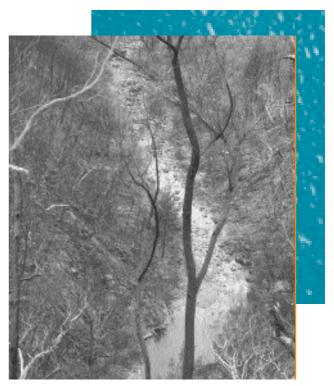
The fires in the Cotter River catchment burnt the vegetation right to the water's edge, exposing the water to sunlight all day long.

The bushfires in ACT and Kosciuszko National Park have burned right to the edges of streams such as the Cotter River, the Perisher Creek and the Thredbo River. With no leaves on the riverbank trees and shrubs, and only patches of overhanging grasses, the streams are open to the sunlight through much of the day. Water temperatures are likely to be higher as a result.

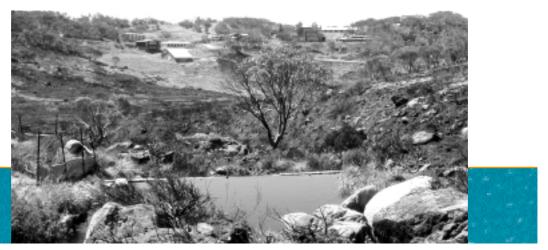
Pipers Creek, Koscuiszko National Park, pump station weir which was edged by dense alpine scrub before the January fires. Photo: C Lemann
